There are two ways to check if your AIDD-1000 scanner is worn:

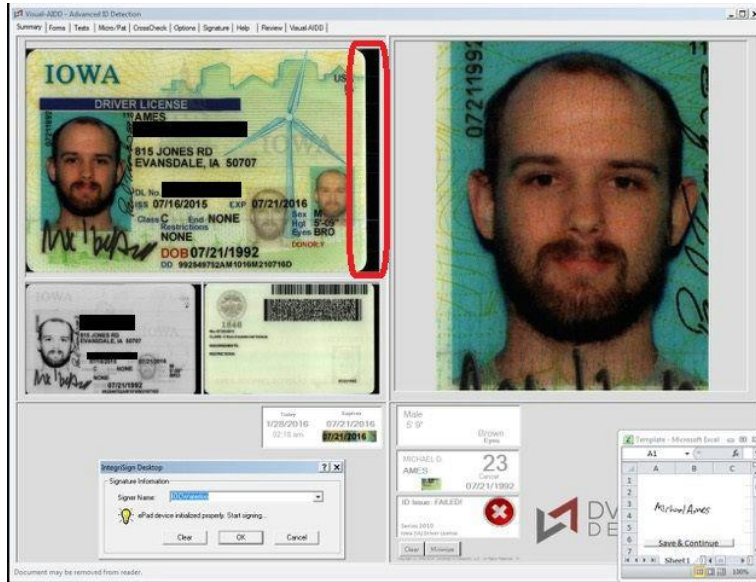
1) When you scan an ID, you may notice a black vertical band on the right side of the scanned image. The wider this gets, the more likely you are to have errors in your results. Below is an image of a good example of a scan from an AIDD-1000 that is very worn out.

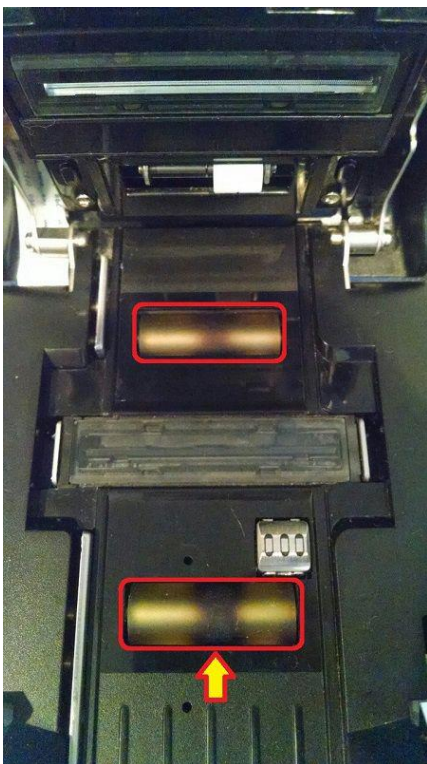
FIGURE 1

2) Also, if you open the lid of your AIDD-1000, you can visually inspect the rollers directly. FIGURE 1: The customer has either never or very rarely cleaned their scanner. FIGURE 2: This is how a brand new scanner looks like.
